Navajo Abandoned Uranium Mine

Site Screen Report

School Boy AUM Site

August 2010

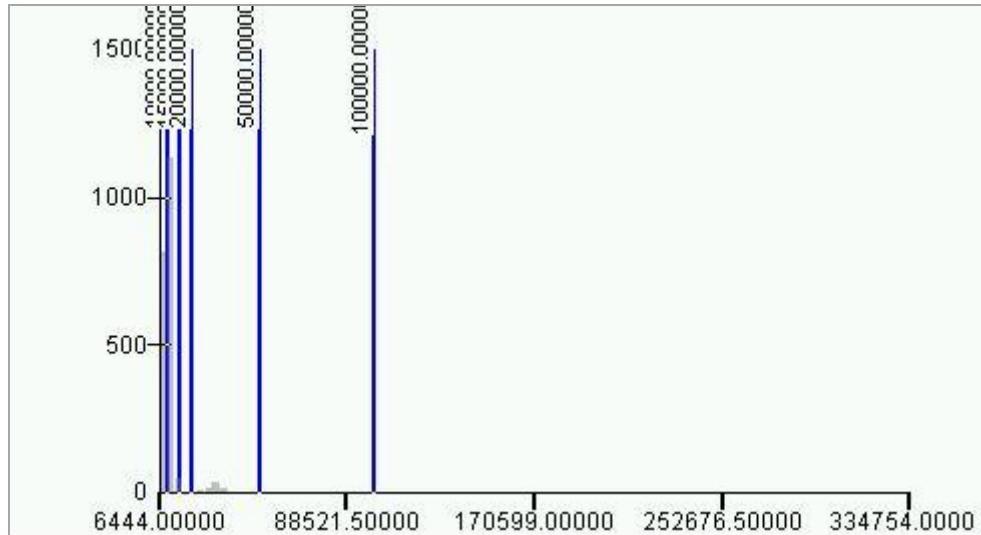
A total of 2,089 gamma radiation measurements were collected from the mine site, ranging from 6,444 cpm to 334,754 cpm. Measurements collected in the vicinity of the waste debris were found at levels ranging from approximately 60,000 cpm to 330,000 cpm. The measurements are represented in Figures 1 and 2.
